# Coastal erosion and accretion on the Caribbean coastline of Costa Rica long-term observations

Several studies show erosive processes on the Caribbean coastline of Costa Rica. These processes may be accelerated as a result of an increase in the sea level. This study covered the entire Caribbean coastline of Costa Rica between 1986 and 2019. This allowed reporting new sites with accelerated coastal accretion and erosion processes, as well as confirming other processes that have already been identified. The methodology was based on shoreline rising images obtained from Landsat and on their processing in a Geographical Information System supported with the “Digital Shoreline Analysis System” (DSAS) tool. The presence of important accretion areas related to the mouth of significant fluvial systems, such as Colorado, Parismina, Matina, Estrella, and Sixaola rivers is highlighted. Moreover, eight beach sectors showing erosion problems have been analyzed. The beach located to the south of Isla Portillos and beaches located on Cahuita Point stand out due to their intensity. Additionally, an intense beach erosion process has been detected at Soropta in Panamá. It should be highlighted tha

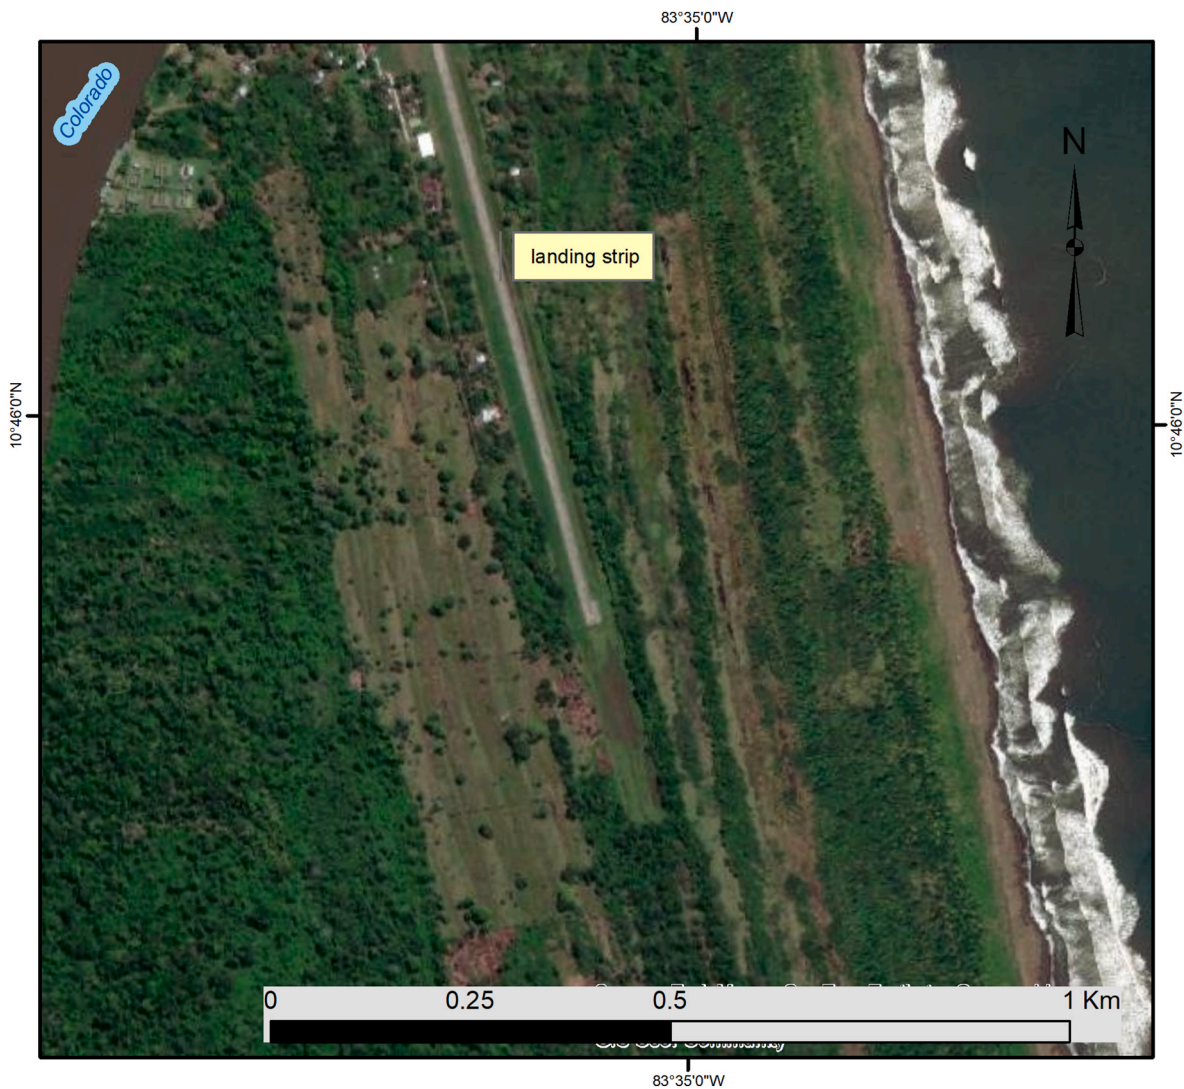
Fig. 4. Beach ridges at Barra del Colorado. Note the presence of beach ridges around the landing strip. Source: satellite image on 01/04/2018, Esri imagery.

Tortuguero sub-basins are part with an extension of  $1,321$  km<sup>2</sup> (Oficina de Desarrollo Sostenible y Medio Ambiente, 1997; Programa de las Naciones Unidas para el Medio Ambiente [PNUMA], 1997). The coastline along the Colorado river mouth, shows a long-standing accretion (progradation) (Fig. 4).

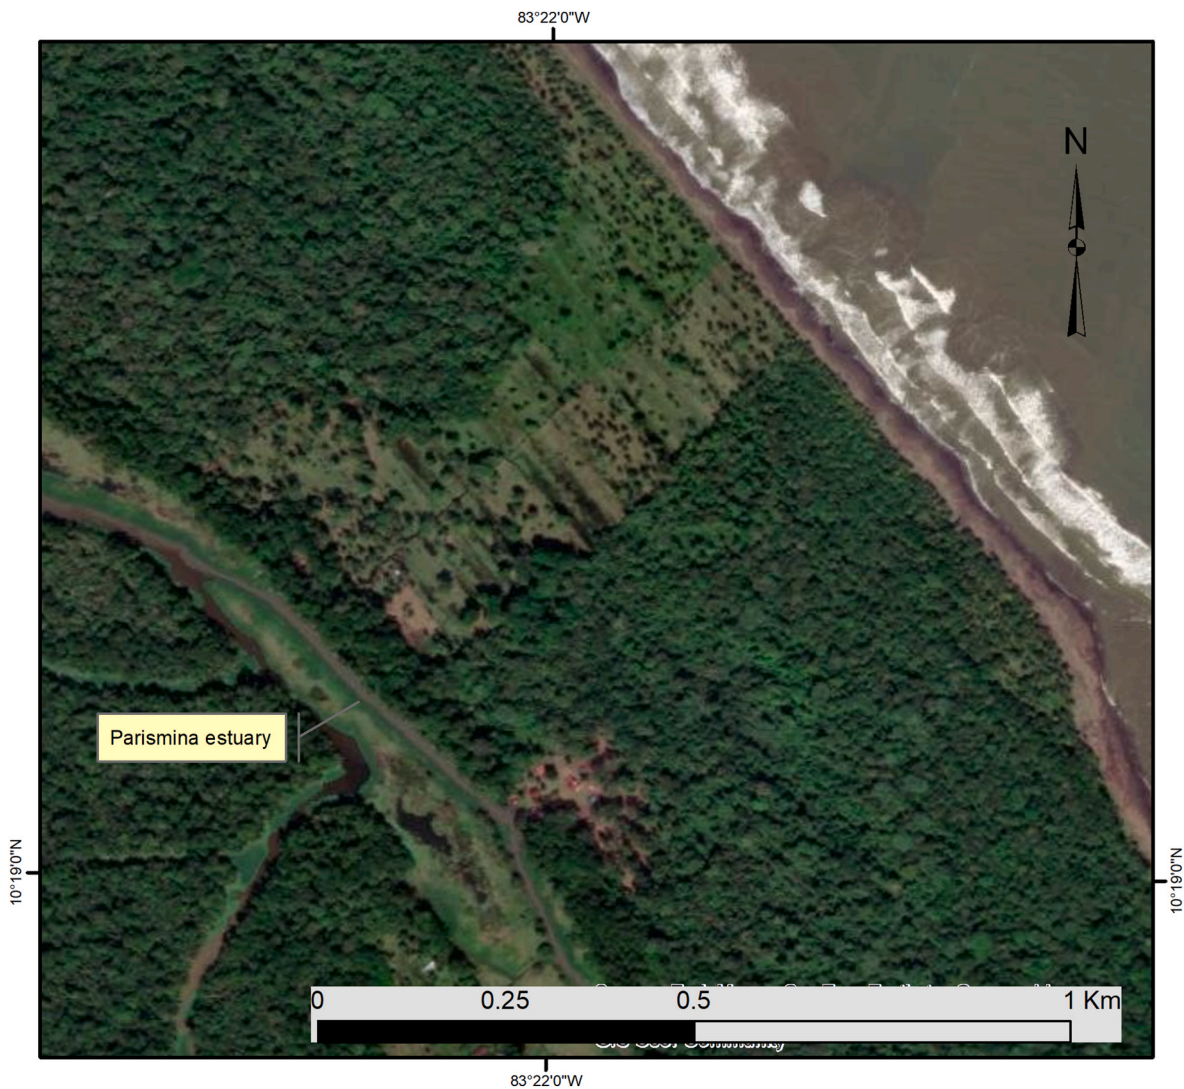
Fig. 5. Beach ridges near the mouth of Parismina River. Note the presence of beach ridges in the deforested land between the shoreline and the estuary (canal). Source: satellite image on 24/12/2023, Esri imagery.

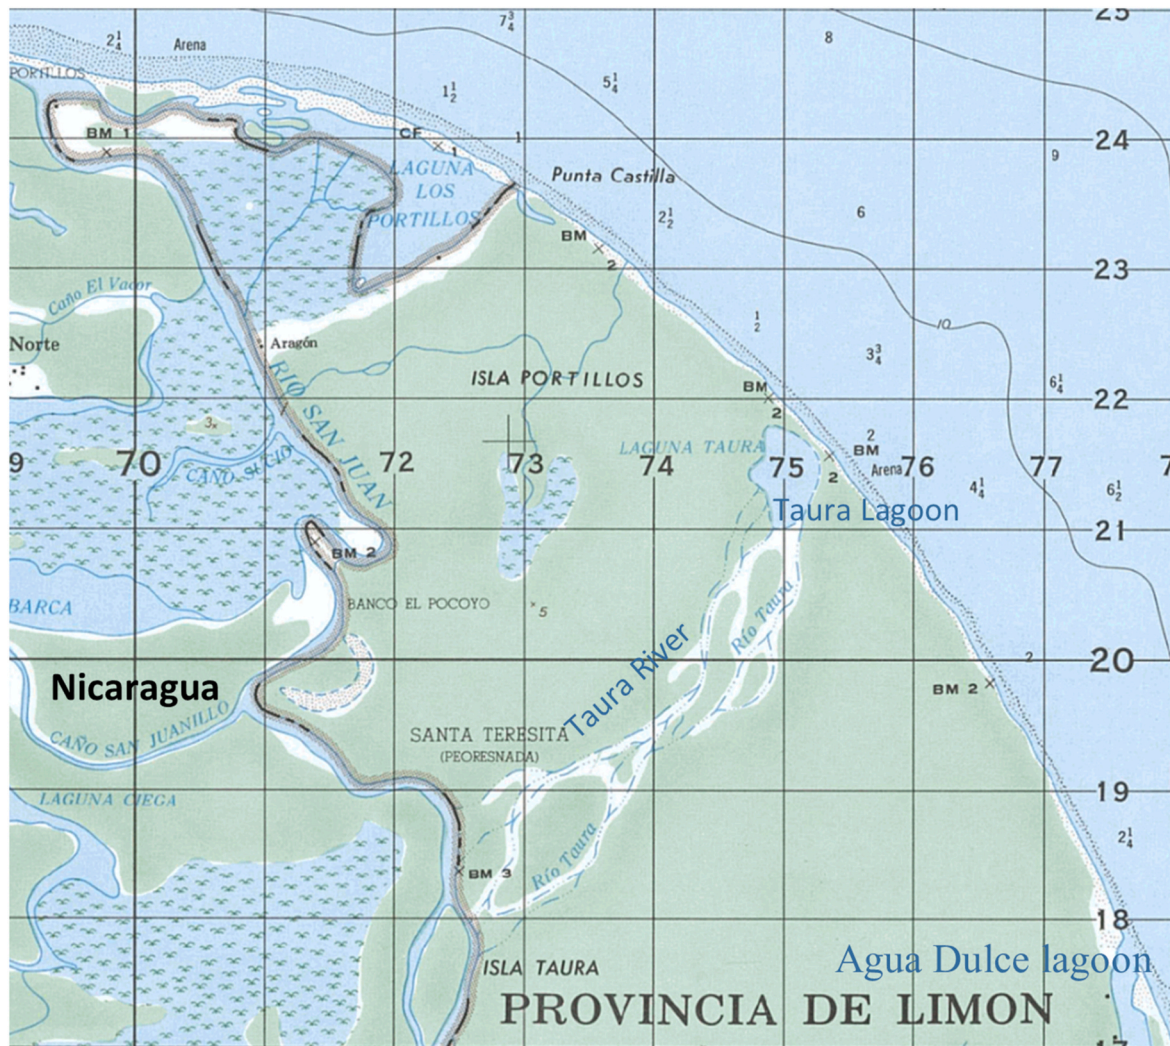
Fig. 7. Abandoned channel of the San Juan River. It is currently constituted as a waterway on which an intermittent river called Taura river flows. Source: Instituto Geográfico Nacional (1988).

The San Juan River mouth prograde leaving a record of beach ridges like those of the Colorado river. However, no coastal belts or beach ridges are observed between Punta Castilla and Taura lagoon (Fig. 7).

To the south of Punta Castilla, a retreat of 300 m in 35 years was estimated based on aerial photographs, which would represent a rate of -8.5 m/y (Nieuwenhuys and Kroonenberg, 1994). The mentioned rate is greater to the one found in this research (-4,7 m). This discrepancy might be due to the different methods both studies, which is not clarified in the study, and to the fact that this research did not include enough shorelines to perform the analysis in Isla Portillos, due to cloud cover (Fig. 7).

Severe erosion process is recorded between Taura and Agua Dulce lagoons (Figs. 2 and 7), which might be related to the closure of an old mouth that currently constitutes an abandoned channel (intermittent river) called Taura river (Fig. 7). In this way, by no longer receiving a significant contribution of fluvial sediment, and due to its direct exposure to the waves (from NE), the redistribution of coastal sediments is produced in response to a strong littoral drift. Nieuwenhuys and Kroonenberg (1994), who stated that erosion in this section has been
