Impact of Extreme Weather Events on the Beaches of Puerto Rico: The Case of Ocean Park, San Juan

Rafael Mendez-Tejeda^{1,*}, Kevián Augusto Pérez-Valentín², Maritza Barreto-Orta³

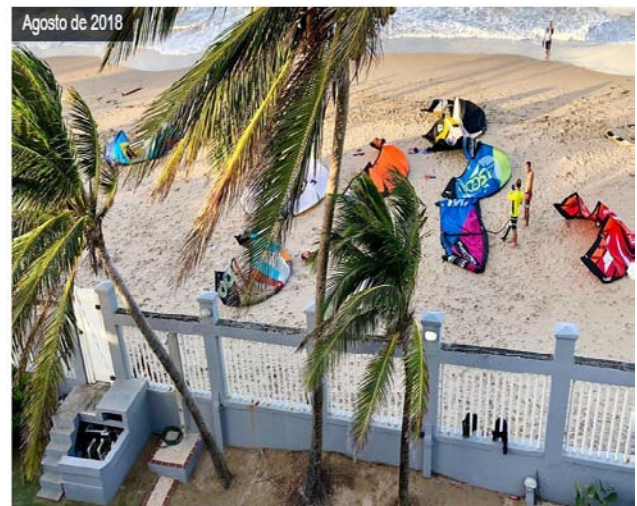
Figure 2. Impacted area the first week of August 2019. Source: Endi-JuxtaposeJs

An initial field survey was done to identify the areas of major beach erosion for further monitoring (Figure 2 and Figure 3). Among the findings, we can highlight the presence of a vertical cut (microcliff) with a height of 2.4 m (Figure 4), the exposure of small lenses of beachrock in areas of former beach, the shift toward a concave beach profile, the exposure of previous informal mitigation structures, and sand loss (along an approximately 25-m long strip parallel to the coast). This microcliff was caused by strong wave activity, especially when waves with limited swash and stronger backwash withdraw sediments, cutting into the beach profile and leaving an erosional profile. Based on field observations, the swell coming from the northeast is also associated with the removal and transference of sediments to other areas of the coast. The stratigraphy of the beach was examined using 1.6 m of exposure (microcliff) (Figure 5 and Figure 6).

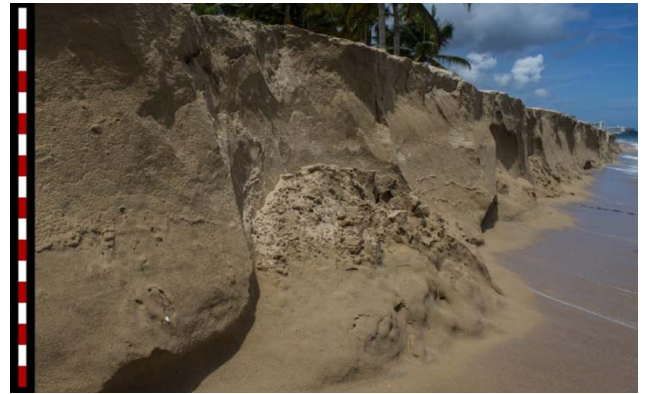
Figure 5. Microcliff or erosional cut (about 1.8 m high; Intervals every 10 cm). Source: Pérez-Valentín

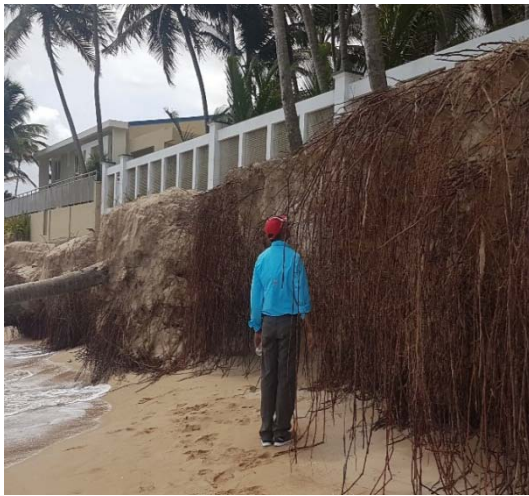
Figure 4. Vertical cut produced by wave impact during the second week of August 2019. Source: Méndez-Tejeda

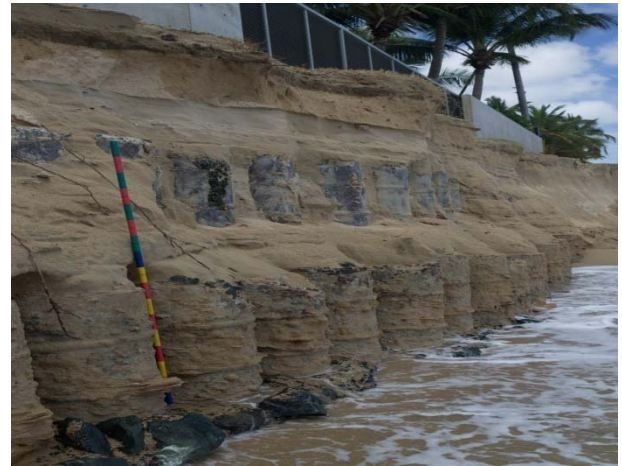
Figure 6. Exposure of informal coastal mitigation structures (Jacob's staff with 10-cm intervals). These containers were used to fill in from 1930 to 1940. Later, constructions were built. Image: Pérez-Valentín

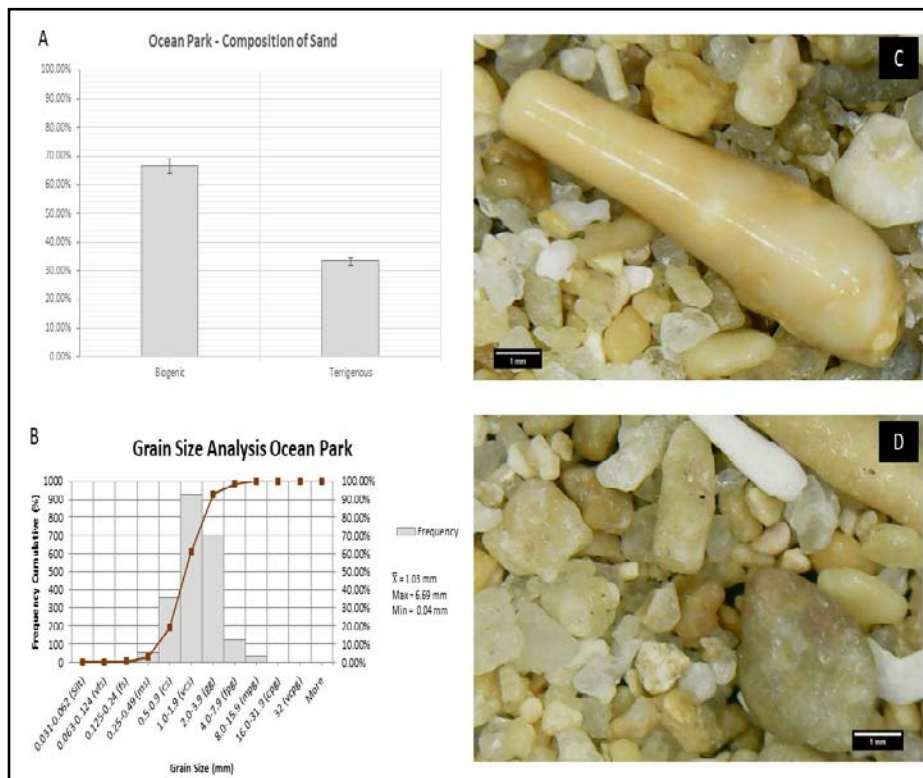
Figure 7. A) Graph of sand composition showing 66.65% biogenic components and 33.35% terrigenous material. B) Histogram of grain sizes (8/8/19). C and D) Photomicrographs of Ocean Park sand. Note the abundance of calcareous sand particles (echinoderm spine). Source: Pérez-Valentín

The sedimentology of Ocean Park Beach was examined to understand variations in grain size and spatial-temporal changes associated with beach erosion and depositional processes. The composition of the sediments was heterogeneous (of mixed origin), which is expected for this type of depositional environment. The current beach composition was dominated by biogenic calcareous clasts (66.65%) and terrigenous material (33.35%) (Figure 7). This composition suggests the contribution of fluvial sediments as terrigenous clasts (e.g., quartz, lithic fragments, and minor occurrence of magnetite) which appear to be incorporated with fragmented calcareous marine material (e.g., mollusk shells and disarticulated echinoderms) derived from the nearshore reef area (Figure 7 and Figure 8). In addition, the granulometric analysis revealed a wide range of grain sizes (from very fine sand to medium pebbles). In order to characterize coastal sediments, it is not adequate to examine grain size from a single sample or assume spatial uniformity [20]. Changes in granulometric distribution were documented not only in the microcliff area but also horizontally along the beach. Sedimentological parameters should be considered in the mitigation process of the coast. However, it is important to recognize the causes of coastal erosion are not only limited to changes in currents or wave activity but are multifactorial and require detailed study. This beach and its sands serve as a refuge for dozens of Leatherback sea turtles (*Dermochelys coriacea*) that arrive every year to lay their eggs, which then hatch along the beach.
